SCREENING SITE INSPECTION REPORT  
FOR  
BEMIS COMPANY, INC.  
PEORIA, ILLINOIS  
U.S. EPA ID: ILD006215727  
SS ID: NONE  
TDD: F05-8812-011  
PAN: FIL0585SA

AUGUST 3, 1990

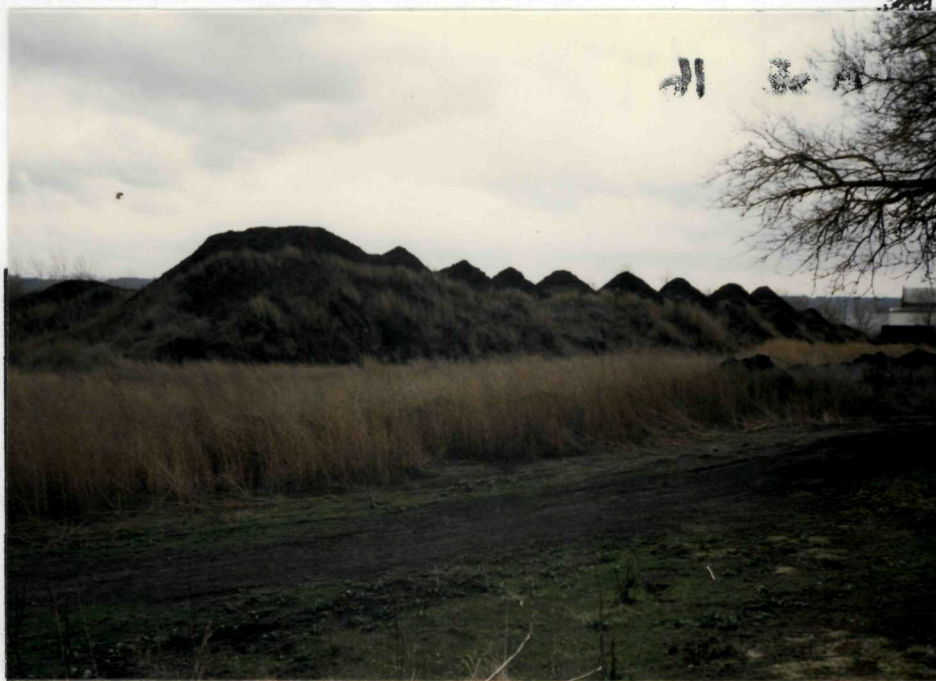
The fly ash settlement pond, located west of the cooling canal, was filled with fly ash to an estimated height of approximately 40 to 50 feet. This pile was surrounded by tall grasses. In the southwest corner of the fly ash settlement pond, a pool of water approximately 6 inches deep was observed. The pool formed a small ditch 3 to 4 feet wide, which wound its way toward the fly ash pile. The source of the pooled water may have been a basement pump.

However, a potential does exist for TAL analytes and/or TCL compounds to be carried off-site via particulates from the fly ash pile on-site, if the fly ash contains TAL analytes or TCL compounds. The fly ash pile is not completely vegetated and could release particulates when dry, dusty conditions prevail.

DESCRIPTION: PERSPECTIVE OF FLY ASH PILE.

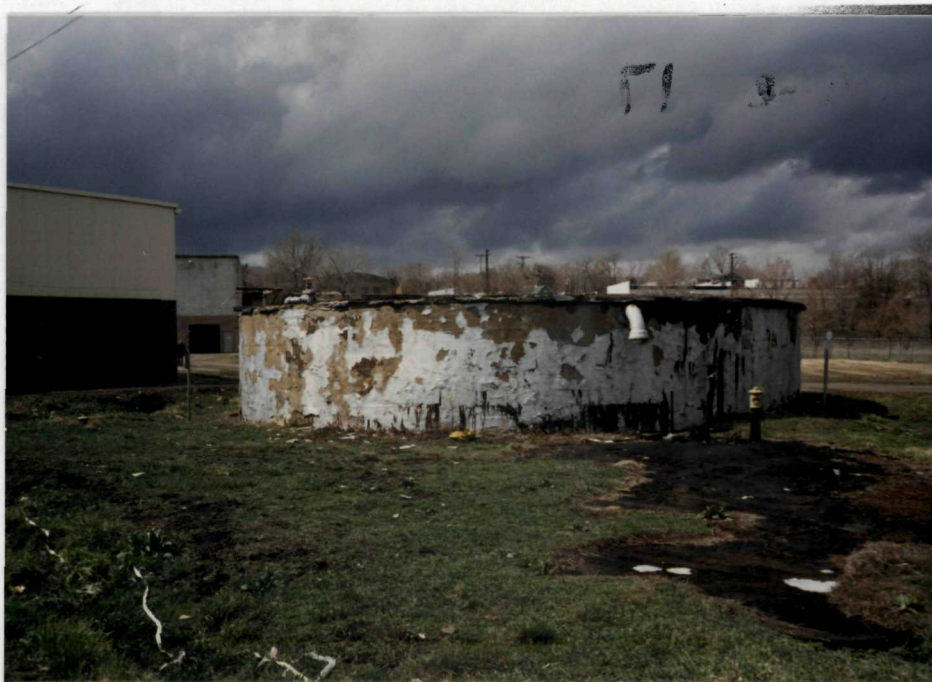
Farther north, outside a brick and metal storage building, a large oil tank was observed. Ivex is currently making plans for removal of the tank (Rohman 1989). A small gully was observed near the oil tank. The gully sloped in an easterly direction from the storage building toward the river.

DESCRIPTION: PERSPECTIVE OF OIL TANK.

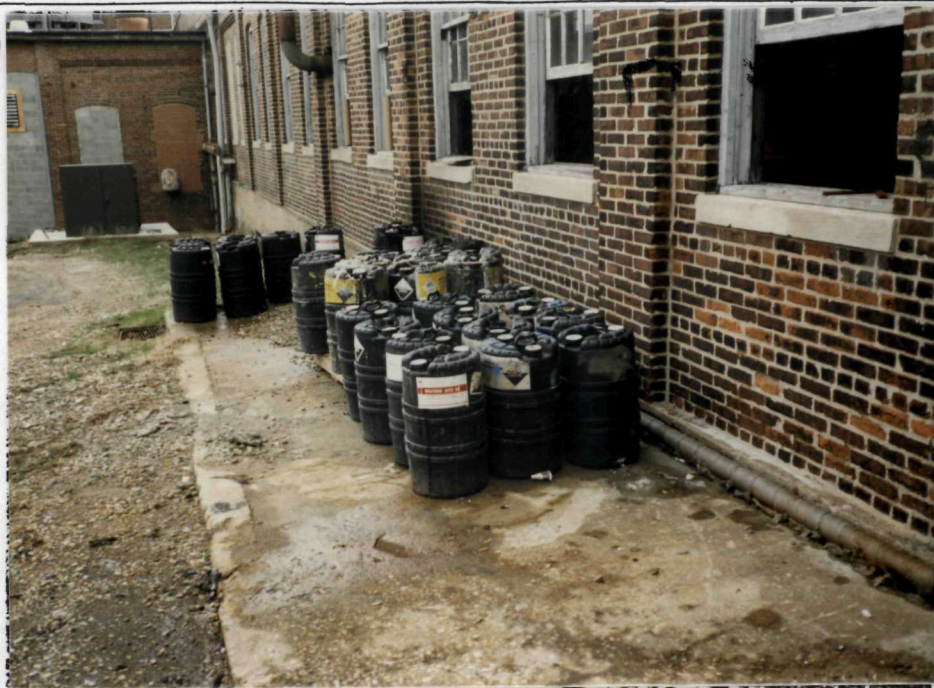
Approximately 30 barrels were observed outside one of the brick buildings on the Ivex portion of the site. Some barrels were labeled muriatic acid (also known as hydrochloric acid) and some, sulfuric acid.

DESCRIPTION: PERSPECTIVE OF BARRELS OF ACID LOCATED ON  
IVEX PROPERTY.
